2023 AARP Walk Audit Report

How the Walk Audit Was Conducted

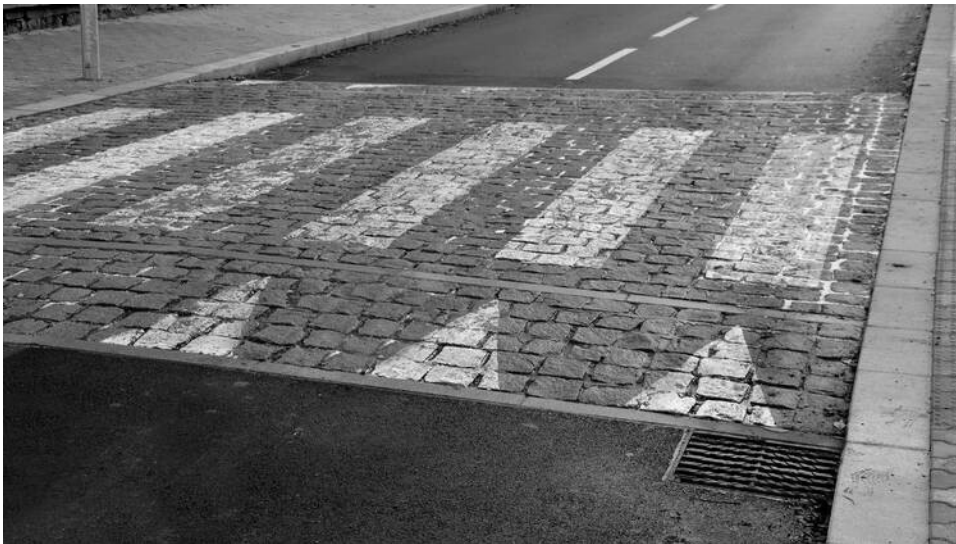
Raised Crosswalk: Ramped speed tables spanning the entire width of the roadway. The crosswalk is demarcated with paint and/or special paving materials. These crosswalks allow pedestrians to cross at grade with the sidewalk, make pedestrians more visible to oncoming traffic and encourage cars to slow down

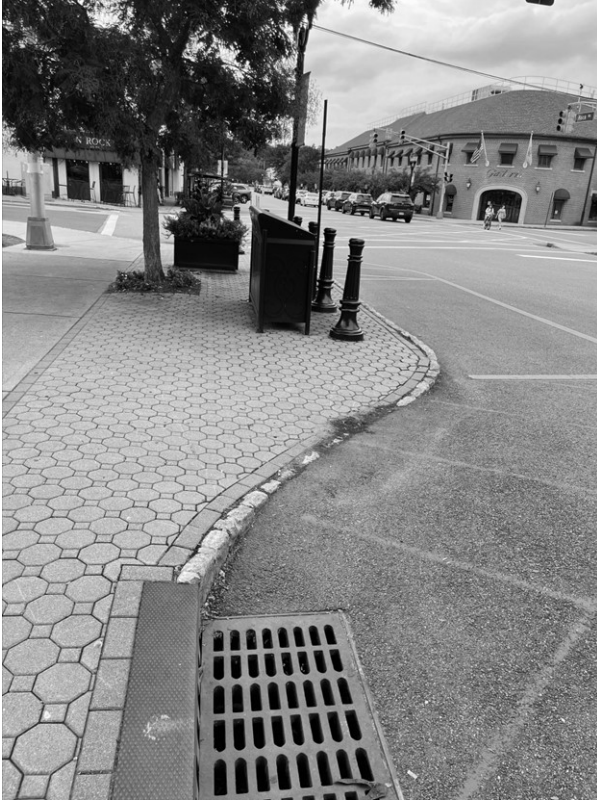
Bump Out: A widening or extension of the sidewalk into the road at a specified location. This creates additional space for pedestrians on the sidewalk, increases pedestrian safety, and slows cars.

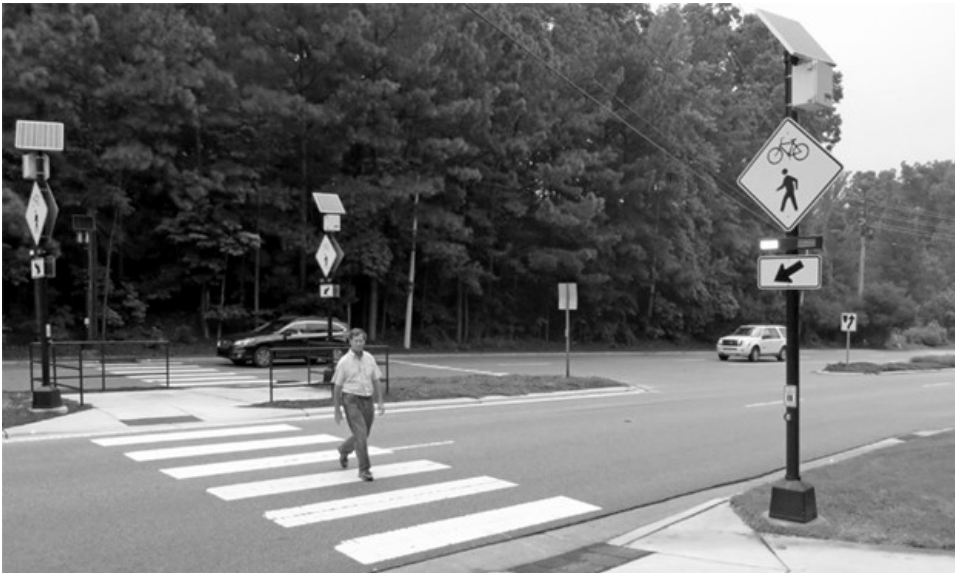
Pedestrian Beacon: A traffic control sign designed to help pedestrians safely cross higher-speed roadways at midblock crossings and uncontrolled intersections by highlighting to drivers that this is a pedestrian crossing area.

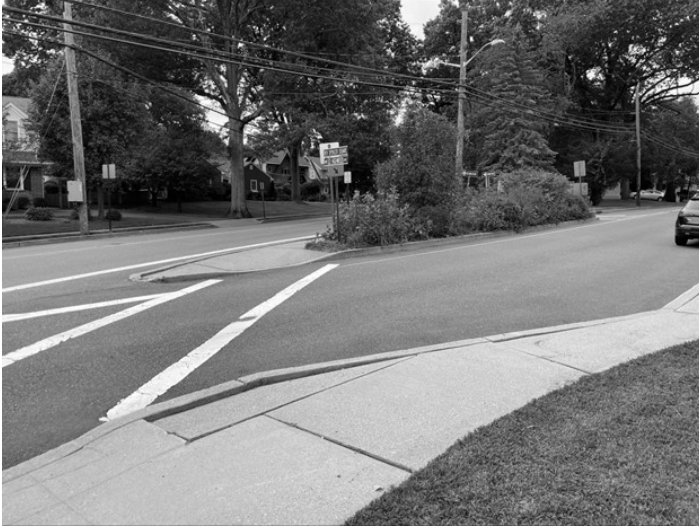
Pedestrian Island: a small section of pavement or sidewalk in the middle of a road, often covered with grass and landscaping, where pedestrians can stop before finishing crossing the road.
